**Flood Control Project Maintenance  
Levee Inspections****LMA District Cover Sheet****Spring 2016 Levee Inspection Results****Reclamation District No. 0544 Upper Roberts Island**

**Spring 2016 Levee Inspection Results**

**Reclamation District No. 0544 Upper Roberts Island**

Waterway			Bank	Unit Miles
Unit No. 01 San Joaquin River			Left	6.05
	Spring (March - May)	Summer (June - August)	(September - November) Fall	Winter (December - February)
Unit Maintenance Rating (Fall Only)				
Date of Inspection	4/19/2016 - 4/19/2016			
DWR Inspector	Richard Willoughby			
Accompanied By

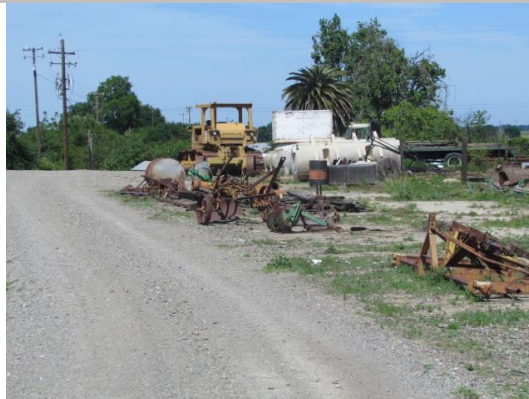
Photo 1 of 4 : SP\_2016\_RD0544\_109\_18\_20160421\_00086.jpg

LM Start	<b>1.15</b>	Rating **	M	Issue No.	<b>18 (cont)</b>
LM End	<b>1.22</b>	Issue Type +	En	Location *	LS

Looking southwest at farm equipment stored on landward landing. (spring 2016)

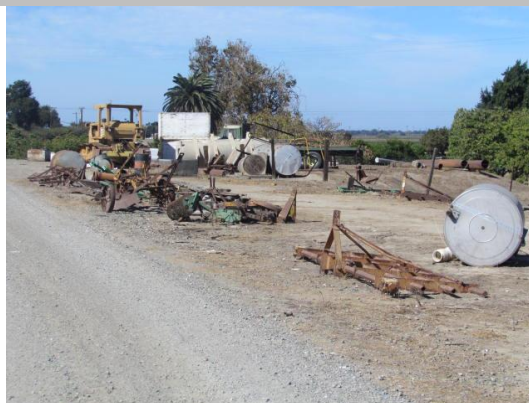
Photo 2 of 4 : SP\_2016\_RD0544\_109\_18\_20160404\_00024.jpg

Looking southwest at equipment stored on landward shoulder. (spring 2015)

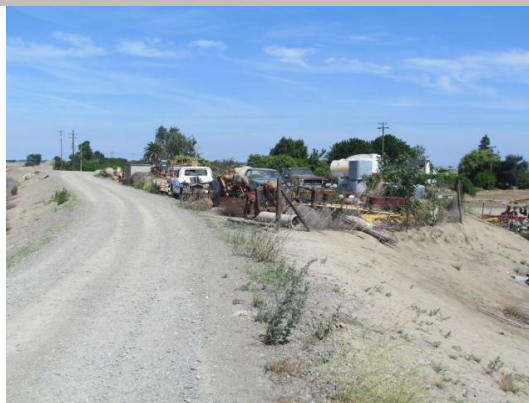
Photo 3 of 4 : SP\_2016\_RD0544\_109\_18\_20160404\_00025.jpg

LM Start	<b>1.15</b>	Rating **	M	Issue No.	<b>18 (cont)</b>
LM End	<b>1.22</b>	Issue Type +	En	Location *	LS

Looking southwest at vehicles and farm equipment stored on landside landing. (spring 2014)

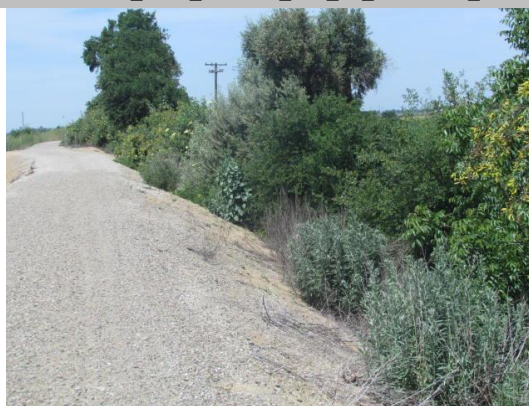
Photo 1 of 2 : SP\_2016\_RD0544\_109\_49\_20160404\_00041.jpg

LM Start	1.30	Rating **	U	Issue No.	49
LM End	1.40	Issue Type +	Ma	Location *	WS
Category	Earthen Levee			GPS Latitude/Longitude	
				Start	End
Item	Vegetation			37.820767 °	37.821582 °
				-121.336611 °	-121.338102 °
DWR ID	DWR_RD0544_02_f_2014_49				
Comment Code					
V2 : Remove the wild growth other than native grasses from the levee slopes.					
Inspector Comment					
Tobacco plants on waterward slope.

Looking southwest at dense vegetation on landward slope and toe.

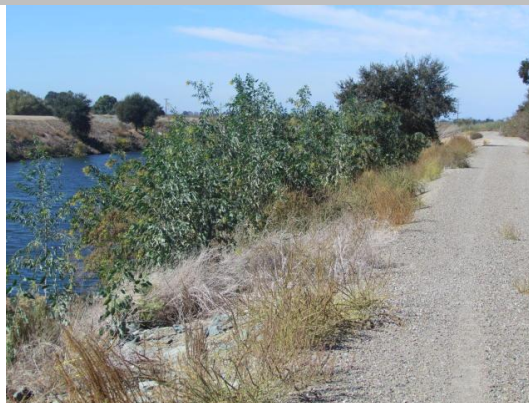
Photo 2 of 2 : SP\_2016\_RD0544\_109\_49\_20160404\_00042.jpg

LM Start	<b>1.30</b>	Rating **	U	Issue No.	<b>49 (cont)</b>
LM End	<b>1.40</b>	Issue Type +	Ma	Location *	WS

Looking south at several tobacco plants on waterward slope.

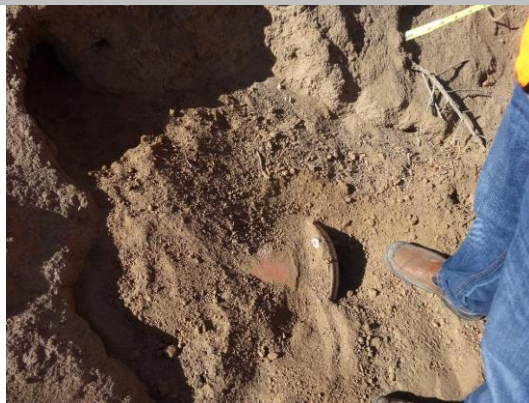
Photo 2 of 2 : UCIP\_SP\_2016\_46674\_44889.jpg

LS view: steel pipe on levee slope with opened end. Levee slope erosion around the pipe.

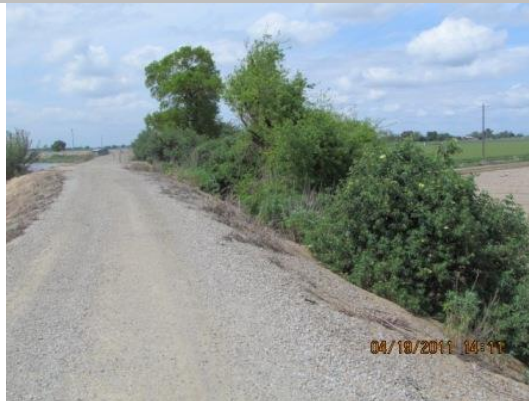
Photo 1 of 2 : SP\_2016\_RD0544\_109\_10\_20160404\_00018.jpg

LM Start	1.38	Rating **	U	Issue No.	10
LM End	1.38	Issue Type +	Ma	Location *	LS
Category	Earthen Levee			GPS Latitude/Longitude	
				Start	End
Item	Vegetation			37.821423 °	37.821423 °
				-121.337878 °	-121.337878 °
DWR ID	DWR_RD0544_02_s _ 2012_10				
Comment Code					
V4 : Elderberries are blocking visibility and flood fight capability.					
Inspector Comment					
Dense elderberry on landward slope and toe.

Looking southwest at elderberries on landside slope.

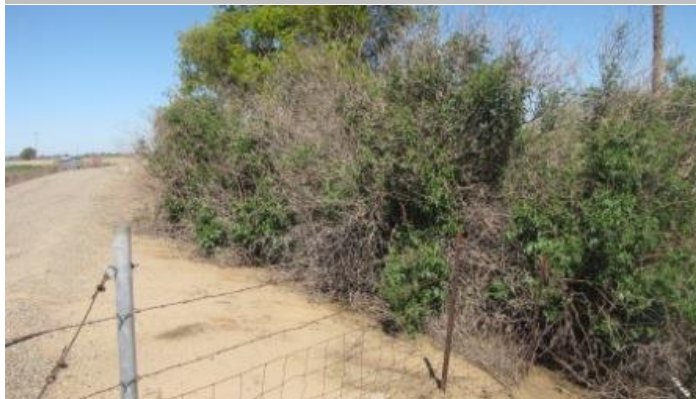
Photo 2 of 2 : SP\_2016\_RD0544\_109\_10\_20160404\_00019.jpg

Looking south at elderberries on landside slope and toe.

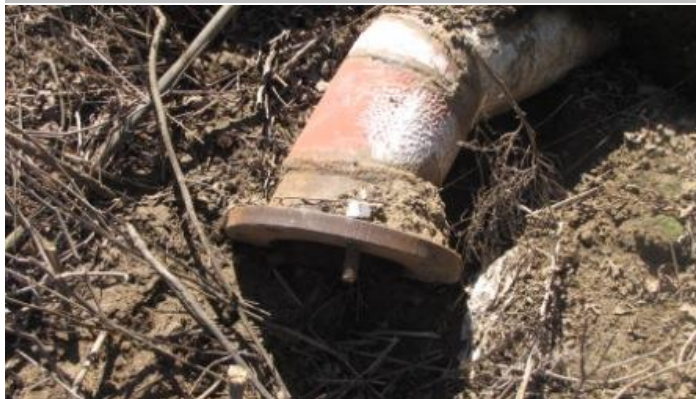
Photo 1 of 3 : SP\_2016\_RD0544\_109\_21\_20160404\_00028.jpg

LM Start	1.39	Rating **	A/W	Issue No.	21
LM End	1.39	Issue Type +	En	Location *	LS
Category	Earthen Levee			GPS Latitude/Longitude	
				Start	End
Item	Encroachments			37.821463 °	37.821463 °
				-121.337900 °	-121.337900 °
DWR ID	DWR_RD0544_02_s _ 2012_21				
Comment Code					
PI : Pipe					
Inspector Comment					
Pipe should be removed or properly abandoned.

Looking east at pipe on landside slope.

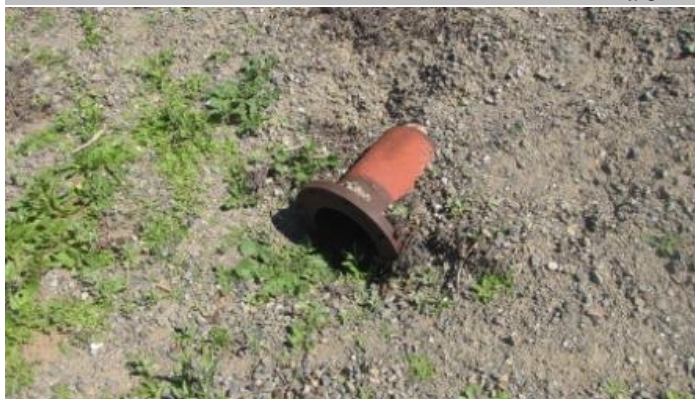
Photo 2 of 3 : SP\_2016\_RD0544\_109\_21\_20160404\_00029.jpg

LM Start	1.39	Rating **	A/W	Issue No.	21 (cont)	
LM End	1.39	Issue Type +	En	Location *	LS	
Category	Earthen Levee			GPS Latitude/Longitude		
				Start		End
Item	Encroachments			37.821463 °	37.821463 °	
				-121.337900 °	-121.337900 °	
DWR ID	DWR_RD0544_02_s_2012_21					
Comment Code						
PI : Pipe						
Inspector Comment						
Pipe should be removed or properly abandoned.

Looking west at east end of pipe on waterside slope.

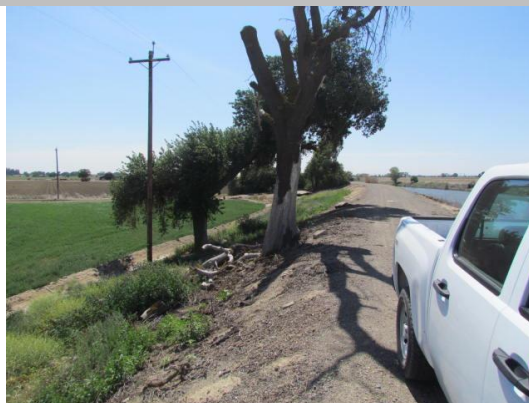
Photo 1 of 1 : SP\_2016\_RD0544\_109\_23\_20160404\_00033.jpg

LM Start	1.46	Rating **	M	Issue No.	23
LM End	1.46	Issue Type +	En	Location *	LS
Category	Earthen Levee			GPS Latitude/Longitude	
				Start	End
Item	Encroachments			37.822082 °	37.822082 °
				-121.338932 °	-121.338932 °
DWR ID	DWR_RD0544_02_s_2012_23				
Comment Code					
TR : Tree or limb					
Inspector Comment					
Dead tree and limbs should be removed from landside shoulder and slope.

Looking north at dead tree and tree limbs on landside shoulder and slope.

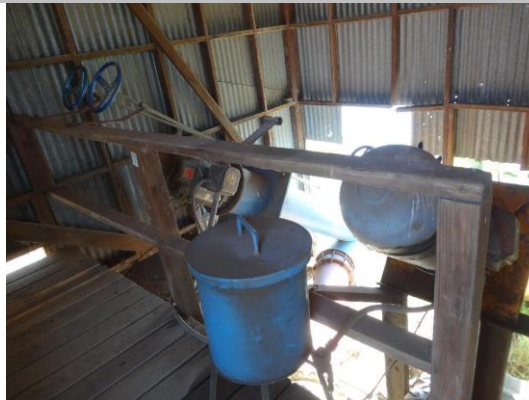
Photo 2 of 2 : UCIP\_SP\_2016\_24288\_42946.jpg

WS view: two pumps discharges water into CMP riser on levee slope.

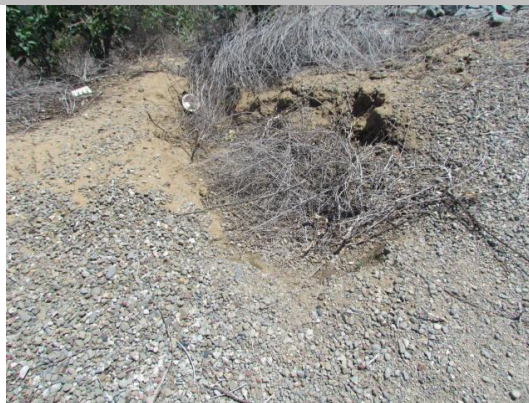
Photo 1 of 2 : SP\_2016\_RD0544\_109\_38\_20160404\_00037.jpg

LM Start	1.86	Rating **	U	Issue No.	38
LM End	1.86	Issue Type +	Ma	Location *	WS
Category	Earthen Levee			GPS Latitude/Longitude	
				Start	End
Item	Erosion / Bank Caving			37.817983 °	37.817983 °
				-121.341682 °	-121.341682 °
DWR ID	DWR_RD0544_02_s_2015_38				
Comment Code					
E1 : Note and monitor erosion site.					
Inspector Comment					
Erosion/Caving on waterward shoulder and slope 18" x 6" x 15'.

Looking southeast at erosion/caving on waterward slope.

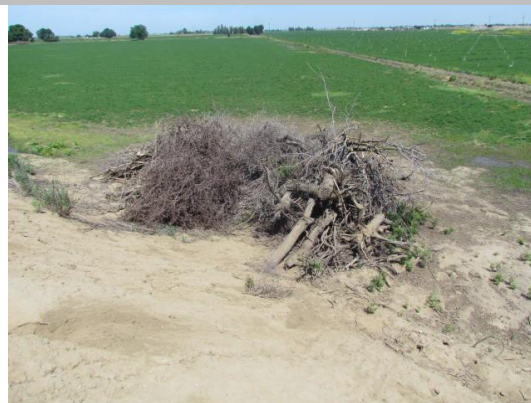
Photo 1 of 1 : SP\_2016\_RD0544\_109\_57\_20160404\_00048.jpg

LM Start	2.02	Rating **	A/W	Issue No.	57
LM End	2.02	Issue Type +	Ma	Location *	LS
Category	Earthen Levee			GPS Latitude/Longitude	
				Start	End
Item	Encroachments			37.818853 °	37.818853 °
				-121.343473 °	-121.343473 °
DWR ID	DWR_RD0544_02_s_2015_57				
Comment Code					
PR : Prunings					
Inspector Comment					
Large pruning pile at landward toe.

Looking west at pruning pile at landward toe.(Spring 2015)

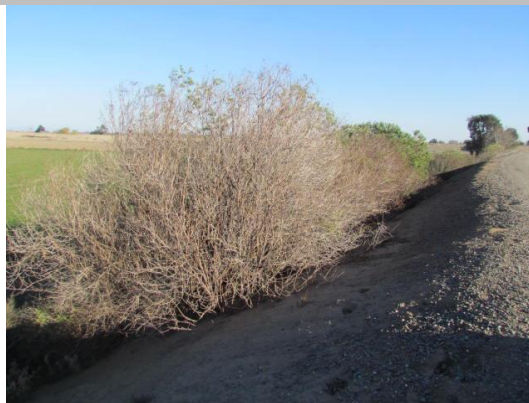
Photo 1 of 1 : SP\_2016\_RD0544\_109\_13\_20160404\_00022.jpg

LM Start	2.07	Rating **	M	Issue No.	13
LM End	2.09	Issue Type +	Ma	Location *	LS
Category	Earthen Levee			GPS Latitude/Longitude	
				Start	End
Item	Vegetation			37.819337 °	37.819460 °
				-121.344275 °	-121.344492 °
DWR ID	DWR_RD0544_02_s_2012_13				
Comment Code					
V4 : Elderberries are blocking visibility and flood fight capability.					
Inspector Comment

Looking northwest at elderberries on landside slope and toe.

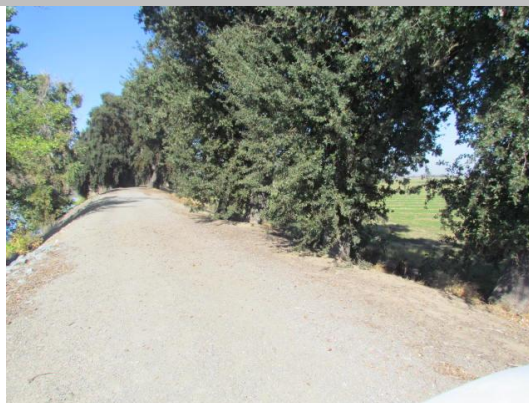
Photo 1 of 1 : SP\_2016\_RD0544\_109\_59\_20160404\_00050.jpg

LM Start	2.12	Rating **	U	Issue No.	59
LM End	2.12	Issue Type +	Ma	Location *	LS
Category	Earthen Levee			GPS Latitude/Longitude	
				Start	End
Item	Trim / Thin Trees			37.819738 °	37.819738 °
				-121.344922 °	-121.344922 °
DWR ID	DWR_RD0544_02_s_2015_59				
Comment Code					
T1 : Trim trees to at least five feet above ground level.					
Inspector Comment					
Untrimmed trees on landward shoulder and slope.

Looking southwest at untrimmed trees on landward slope and toe fall 2015.

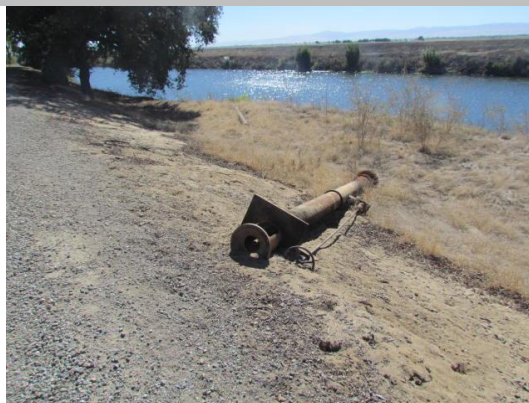
Photo 1 of 1 : SP\_2016\_RD0544\_109\_50\_20160404\_00043.jpg

LM Start	2.21	Rating **	M	Issue No.	50
LM End	2.21	Issue Type +	Ma	Location *	WS
Category	Earthen Levee			GPS Latitude/Longitude	
				Start	End
Item	Encroachments			37.820646 °	37.820646 °
				-121.346014 °	-121.346014 °
DWR ID	DWR_RD0544_02_f_2014_50				
Comment Code					
GA : Garbage					
Inspector Comment					
Discarded intake pipe on waterward slope.

Looking northwest at pipe on waterward slope.

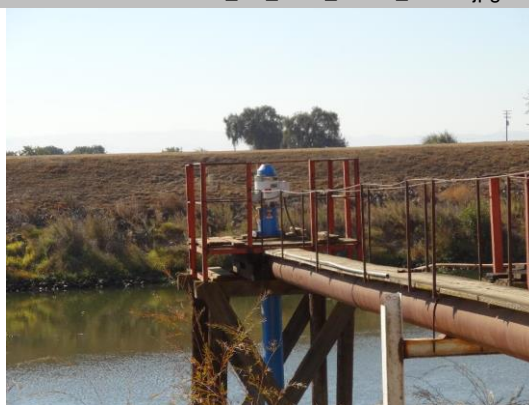
Photo 2 of 2 : UCIP\_SP\_2016\_41731\_42953.jpg

WS view: closer view of pipe, walkway, and pump on pile structure.

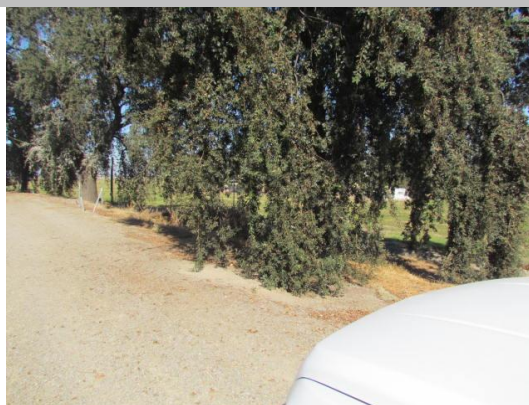
Photo 1 of 1 : SP\_2016\_RD0544\_109\_61\_20160404\_00051.jpg

LM Start	2.28	Rating **	U	Issue No.	61
LM End	2.28	Issue Type +	Ma	Location *	LS
Category	Earthen Levee			GPS Latitude/Longitude	
				Start	End
Item	Trim / Thin Trees			37.821473 °	37.821473 °
				-121.346860 °	-121.346860 °
DWR ID	DWR_RD0544_02_s_2015_61				
Comment Code					
T1 : Trim trees to at least five feet above ground level.					
Inspector Comment					
Untrimmed tree on landward shoulder.

Looking west at untrimmed trees on landward slope fall 2015.

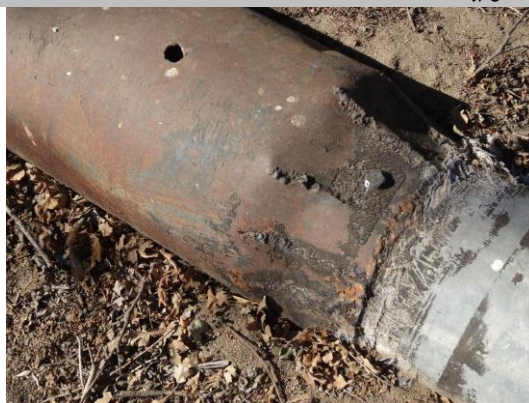
Photo 2 of 2 : UCIP\_SP\_2016\_24293\_42964.jpg

WS view: 12" steel pipe connected to 10" pipe. Holes on pipe top found.

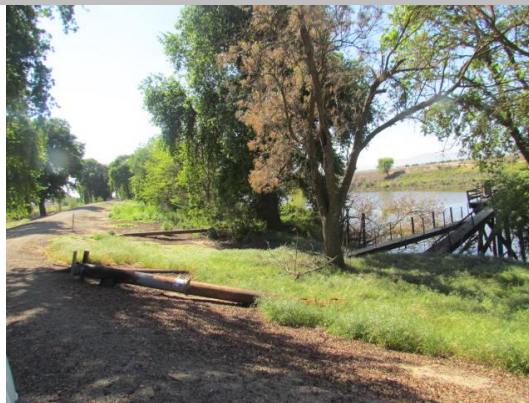
Photo 1 of 1 : SP\_2016\_RD0544\_109\_51\_20160404\_00044.jpg

LM Start	2.31	Rating **	M	Issue No.	51
LM End	2.31	Issue Type +	Ma	Location *	WS
Category	Earthen Levee			GPS Latitude/Longitude	
				Start	End
Item	Encroachments			37.821757 °	37.821757 °
				-121.347181 °	-121.347181 °
DWR ID	DWR_RD0544_02_s_2014_51				
Comment Code					
PI : Pipe					
Inspector Comment					
Landowner repaired pump and replaced pipe and left pump shaft and pipe on waterward slope.

Looking north at old pump shaft and pipe on waterward slope.

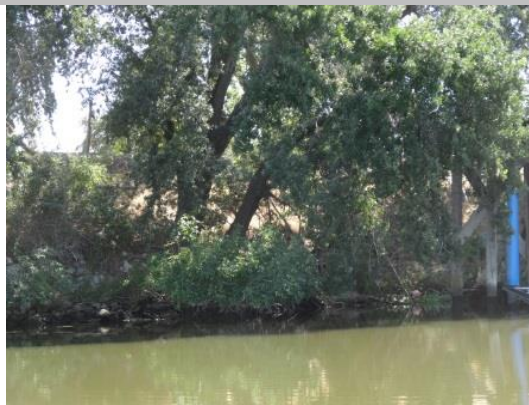
Photo 1 of 2 : SP\_2016\_RD0544\_109\_12\_20160404\_00020.jpg

LM Start	2.31	Rating **	M	Issue No.	12
LM End	2.31	Issue Type +	Ma	Location *	WS
Category	Supplemental			GPS Latitude/Longitude	
				Start	End
Item	DWR Erosion Survey			37.821763 °	37.821763 °
				-121.347275 °	-121.347275 °
DWR ID	DWR_RD0544_02_s_2016_12				
Comment Code					
Inspector Comment					
06/25/2015: No significant change observed. 07/02/2014: No significant change observed. 08/20/2013: No significant change observed. 08/07/2012: The site was first reported in 2012 spring levee inspection report. The data were estimated as the site is underneath a irrigation pump station and inaccessible by boat or land survey. It?s possible the pump station played a role in the erosion. [2015 Site ID:RD0544U02RM33.21]

Front view of the site.

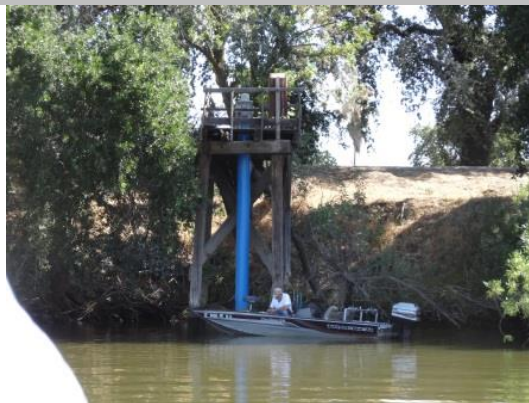
Photo 2 of 2 : SP\_2016\_RD0544\_109\_12\_20160404\_00021.jpg

LM Start	2.31	Rating **	M	Issue No.	12 (cont)	
LM End	2.31	Issue Type +	Ma	Location *	WS	
Category	Supplemental			GPS Latitude/Longitude		
				Start	End	
Item	DWR Erosion Survey			37.821763 °	37.821763 °	
				-121.347275 °	-121.347275 °	
DWR ID	DWR_RD0544_02_s_2016_12					
Comment Code						
Inspector Comment						
06/25/2015: No significant change observed. 07/02/2014: No significant change observed. 08/20/2013: No significant change observed. 08/07/2012: The site was first reported in 2012 spring levee inspection report. The data were estimated as the site is underneath a irrigation pump station and inaccessible by boat or land survey. It's possible the pump station played a role in the erosion. [2015 Site ID:RD0544U02RM33.21]

Front view of the site.

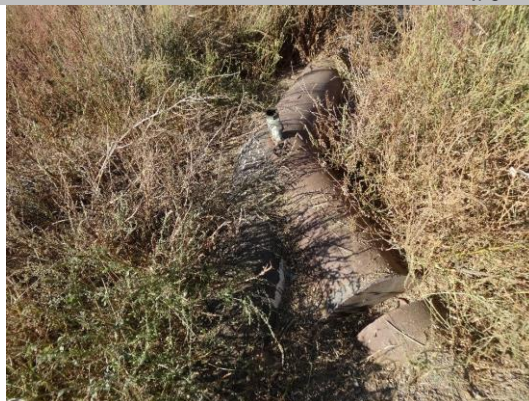
Photo 2 of 2 : UCIP\_SP\_2016\_24295\_42971.jpg

LM Start	2.61	Rating **	M	Issue No.	74 (cont)	
LM End	2.61	Issue Type +	En	Location *	WS	
Category	Supplemental			GPS Latitude/Longitude		
				Start		End
Item	DWR UCIP Field Study			37.818888 °	37.818888 °	
				-121.350390 °	-121.350390 °	
DWR ID						
Comment Code						
Inspector Comment						
FS_ID:24295 DS_ID:22678 EP_NO: 8625A Repair Type: Non-Urgent Crossing Status: Found UCIP Comments: - abandoned crossing. Needs proper abandonment.- pump removed. Pipe discontinued on landside.- pile structure in dilapalated condion. FIELD_STRUCT_DESC: 16-inch steel pipe through the levee, 7.0 feet below the crown. Pump mounted on pile structure in the stream. Siphon breaker on landward shoulder. Power pole on the landward slope. (App. No. 8625A - Irvin Muller) O&M Manual SJR 007, April 1964. FS Date: 10/31/2013

LS view: steel pipe cut out and discontinued (bottom).

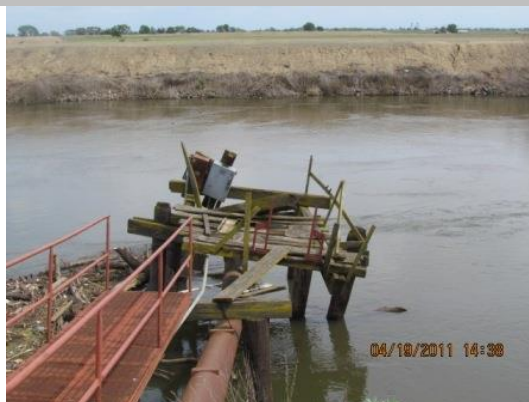
Photo 1 of 1 : SP\_2016\_RD0544\_109\_17\_20160404\_00023.jpg

LM Start	2.61	Rating **	U	Issue No.	17
LM End	2.61	Issue Type +	En	Location *	WS
Category	Rivers, Channels & Designated Floodways			GPS Latitude/Longitude	
				Start	End
Item	Encroachments			37.818872 °	37.818872 °
				-121.350392 °	-121.350392 °
DWR ID	DWR_RD0544_02_s_2012_17				
Comment Code					
Inspector Comment					
Remove dilapidated pump platform from river.

Looking east at dilapidated pump platform.

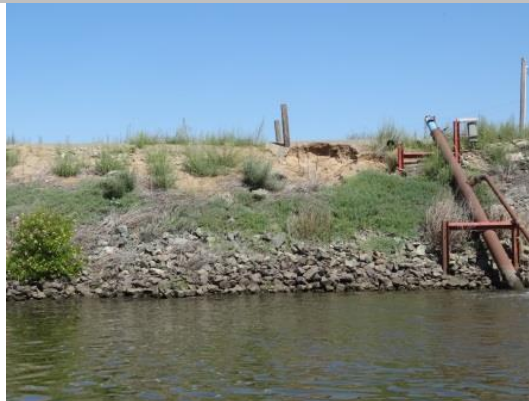
Photo 1 of 3 : SP\_2016\_RD0544\_109\_9\_20160404\_00015.jpg

LM Start	2.61	Rating **	U	Issue No.	9
LM End	2.61	Issue Type +	Ma	Location *	WS
Category	Supplemental			GPS Latitude/Longitude	
				Start	End
Item	DWR Erosion Survey			37.818861 °	37.818861 °
				-121.350400 °	-121.350400 °
DWR ID	DWR_RD0544_02_f_2015_9				
Comment Code					
Inspector Comment					
06/25/2015: The site was discovered during the boat survey. Irrigation pipe leakage caused the soil to sink at the upper levee shoulder. The lower part of the levee is protected by riprap rocks. The irrigation pump was operating at the site. [2015 Site ID:RD0544U02RM33]

Front view of the erosion site.

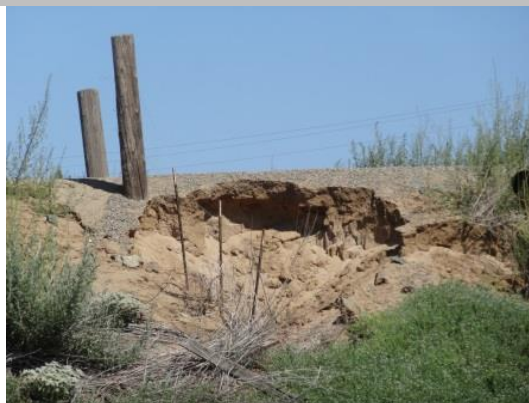
Photo 2 of 3 : SP\_2016\_RD0544\_109\_9\_20160404\_00016.jpg

Close view of the erosion.

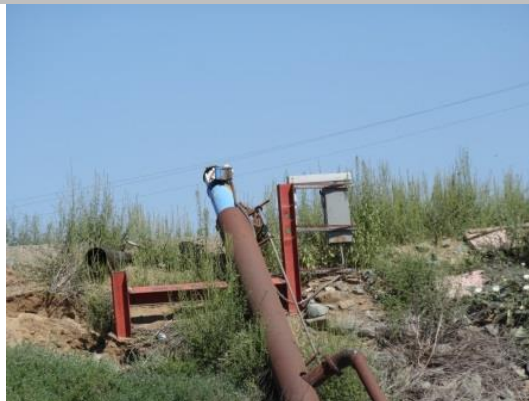
Photo 3 of 3 : SP\_2016\_RD0544\_109\_9\_20160404\_00017.jpg

Close view of the erosion. Vegetation around the site is visible.

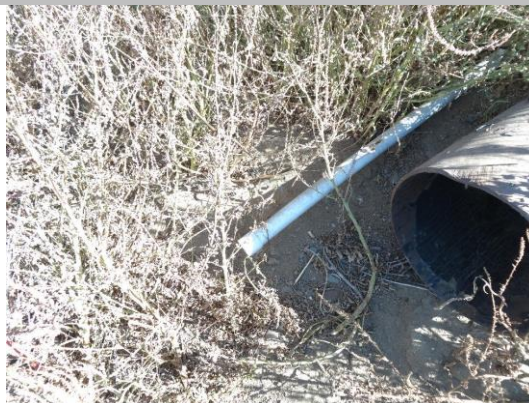
Photo 2 of 2 : UCIP\_SP\_2016\_24297\_42976.jpg

LS view: steel pipe and electric conduit on levee shoulder.

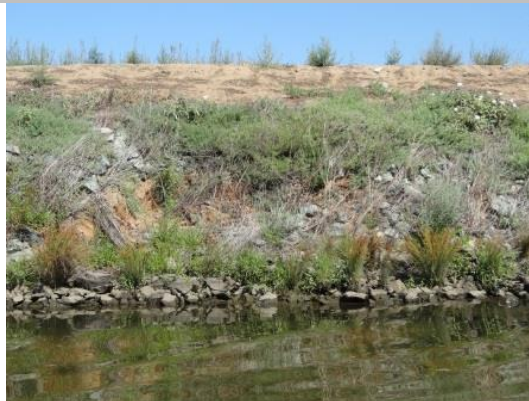
Photo 1 of 2 : SP\_2016\_RD0544\_109\_7\_20160404\_00005.jpg

LM Start	2.67	Rating **	M	Issue No.	7
LM End	2.69	Issue Type +	Ma	Location *	WS
Category	Supplemental			GPS Latitude/Longitude	
				Start	End
Item	DWR Erosion Survey			37.817760 °	37.817760 °
				-121.350850 °	-121.350850 °
DWR ID	DWR_RD0544_02_s_2016_7				
Comment Code					
Inspector Comment					
06/25/2015: No significant change observed. 07/02/2014: No significant change observed. 10/11/2013: No significant change observed. 08/07/2012: Series of pocket erosion were discovered at the levee toe during the boat survey. The area is covered with vegetation and riprap, but the rip rap has been washed away. [2015 Site ID:RD0544U02RM32.91]

Front view of pocket erosion. Note the vegetation and riprap at the site.

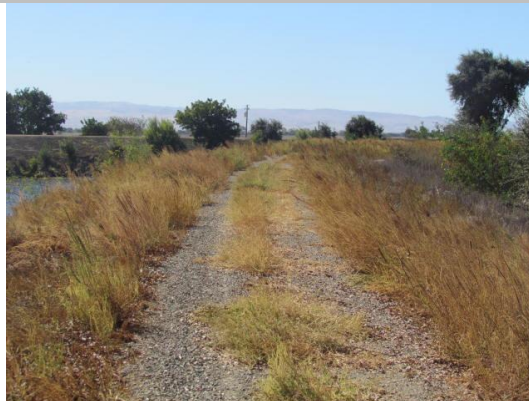
Photo 1 of 1 : SP\_2016\_RD0544\_109\_52\_20160404\_00045.jpg

LM Start	2.69	Rating **	A/W	Issue No.	52
LM End	3.20	Issue Type +	Ma	Location *	CR
Category	Earthen Levee			GPS Latitude/Longitude	
				Start	End
Item	Vegetation			37.817928 °	37.818824 °
				-121.351355 °	-121.359523 °
DWR ID	DWR_RD0544_02_f_2014_52				
Comment Code					
V2 : Remove the wild growth other than native grasses from the levee slopes.					
Inspector Comment

Looking south at vegetation on levee crown.

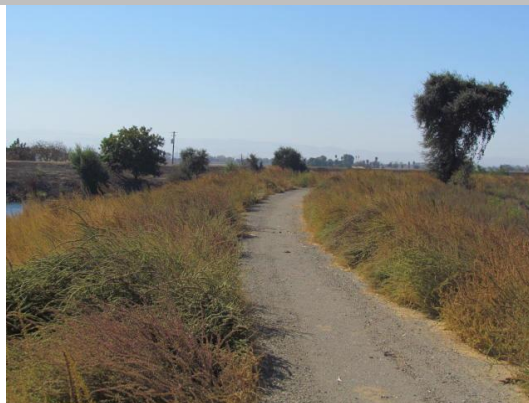
Photo 1 of 1 : SP\_2016\_RD0544\_109\_43\_20160404\_00039.jpg

LM Start	2.71	Rating **	U	Issue No.	43
LM End	3.05	Issue Type +	Ma	Location *	LS
Category	Earthen Levee			GPS Latitude/Longitude	
				Start	End
Item	Vegetation			37.817747 °	37.817497 °
				-121.351578 °	-121.357490 °
DWR ID	DWR_RD0544_02_s_2012_43				
Comment Code					
V2 : Remove the wild growth other than native grasses from the levee slopes.					
Inspector Comment

Looking south a dense vegetation on landward and waterward slope.

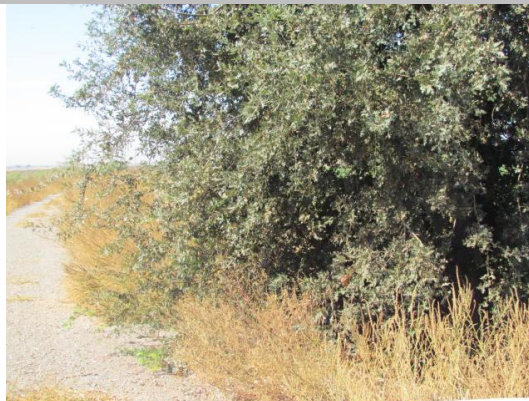
Photo 1 of 1 : SP\_2016\_RD0544\_109\_53\_20160404\_00046.jpg

LM Start	2.80	Rating **	U	Issue No.	53
LM End	2.80	Issue Type +	Ma	Location *	LS
Category	Earthen Levee			GPS Latitude/Longitude	
				Start	End
Item	Trim / Thin Trees			37.817187 °	37.817187 °
				-121.352964 °	-121.352964 °
DWR ID	DWR_RD0544_02_f_2014_53				
Comment Code					
T2 : Thin trees to allow visibility of the ground and room to flood fight.					
Inspector Comment

Looking southwest at untrimmed tree on landward slope fall 2015.

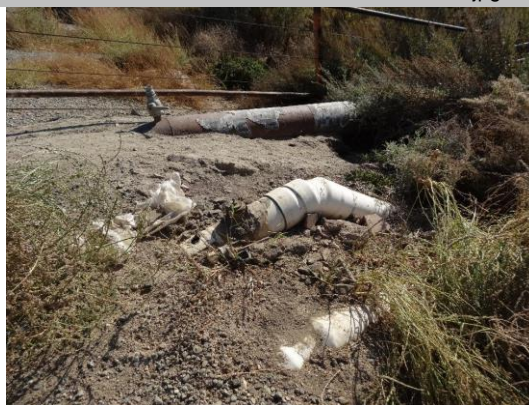
Photo 1 of 2 : UCIP\_SP\_2016\_24908\_44898.jpg

LM Start	3.20	Rating **	M	Issue No.	71
LM End	3.20	Issue Type +	En	Location *	WS
Category	Supplemental			GPS Latitude/Longitude	
				Start	End
Item	DWR UCIP Field Study			37.818824 °	37.818824 °
				-121.359526 °	-121.359526 °
DWR ID					
Comment Code					
Inspector Comment					
FS_ID:24908 DS_ID:22679 EP_NO: 16972 Repair Type: Non-Urgent Crossing Status: Found UCIP Comments: Pump not found on the waterward side.Damaged pipe-plug on waterside. Pipe exposed on both sides of the levee. FIELD_STRUCT_DESC: 1 of 2: Two 8-inch pvc pipes (replaced two 8-inch steel pipes) through the levee, 2.0 feet below the crown. Siphon breaker on waterside. Pump on steel platform in drainage ditch. (App. No. 16972 - Joseph & Gayle Muller) FS Date: 10/31/2013

WS view: 12" steel pipe (top), two 8" white pvc pipes (bottom) on levee shoulder.

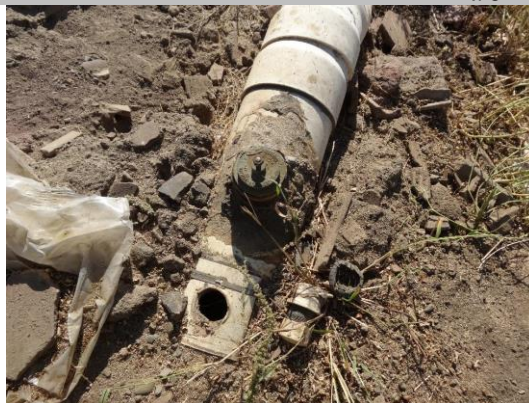
Photo 2 of 2 : UCIP\_SP\_2016\_24908\_44897.jpg

WS view: 8" white pvc pipe with siphon breaker on levee shoulder. An unplugged hole on the pipe.

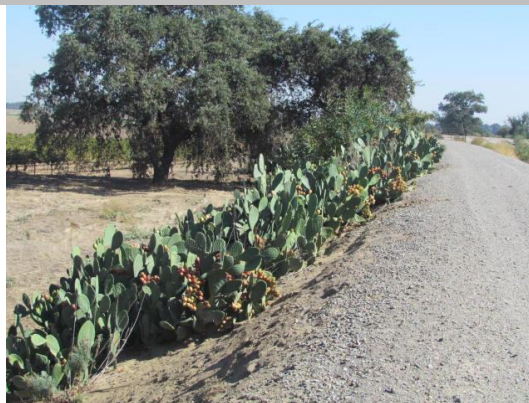
Photo 1 of 3 : SP\_2016\_RD0544\_109\_36\_20160404\_00034.jpg

LM Start	3.48	Rating **	U	Issue No.	36
LM End	3.51	Issue Type +	Ma	Location *	LS
Category	Earthen Levee			GPS Latitude/Longitude	
				Start	End
Item	Vegetation			37.819576 °	37.819530 °
				-121.364056 °	-121.364653 °
DWR ID	DWR_RD0544_02_s_2012_36				
Comment Code					
V2 : Remove the wild growth other than native grasses from the levee slopes.					
Inspector Comment					
Cactus on landside slope.

Looking northwest at cactus on landward slope and toe fall 2015

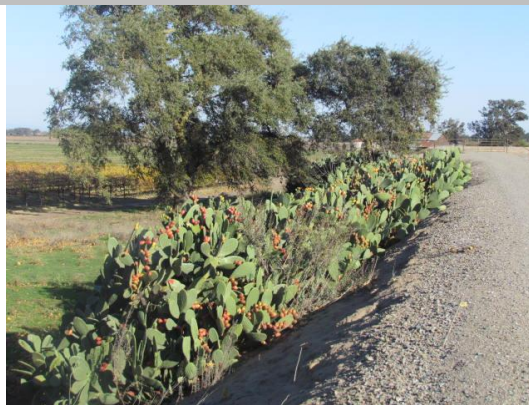
Photo 2 of 3 : SP\_2016\_RD0544\_109\_36\_20160404\_00035.jpg

Looking north at cactus on landside slope and toe spring 2015

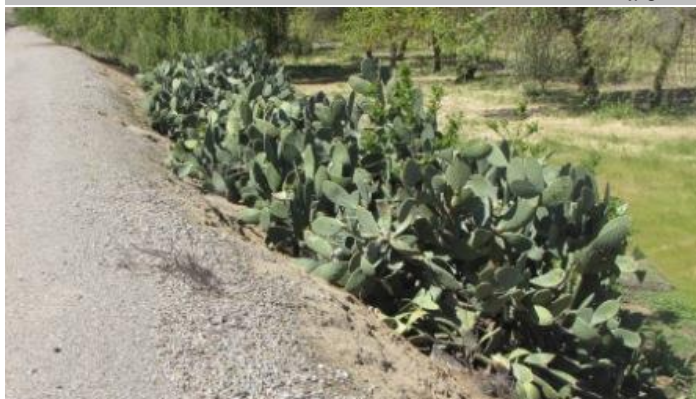
Photo 3 of 3 : SP\_2016\_RD0544\_109\_36\_20160404\_00036.jpg

LM Start	3.48	Rating **	U	Issue No.	36 (cont)	
LM End	3.51	Issue Type +	Ma	Location *	LS	
Category	Earthen Levee			GPS Latitude/Longitude		
				Start		End
Item	Vegetation			37.819576 °		37.819530 °
				-121.364056 °		-121.364653 °
DWR ID	DWR_RD0544_02_s_2012_36					
Comment Code						
V2 : Remove the wild growth other than native grasses from the levee slopes.						
Inspector Comment						
Cactus on landside slope.

Looking southwest at overgrown cactus on landside slope spring 2015.

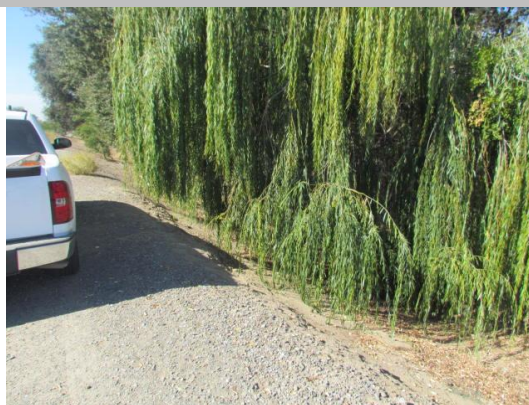
Photo 1 of 1 : SP\_2016\_RD0544\_109\_55\_20160404\_00047.jpg

LM Start	3.49	Rating **	U	Issue No.	55
LM End	3.52	Issue Type +	Ma	Location *	LS
Category	Earthen Levee			GPS Latitude/Longitude	
				Start	End
Item	Trim / Thin Trees			37.819563 °	37.819542 °
				-121.364307 °	-121.364908 °
DWR ID	DWR_RD0544_02_f_2014_55				
Comment Code					
T2 : Thin trees to allow visibility of the ground and room to flood fight.					
Inspector Comment

Looking southwest at untrimmed trees on landward slope and toe fall 2015.

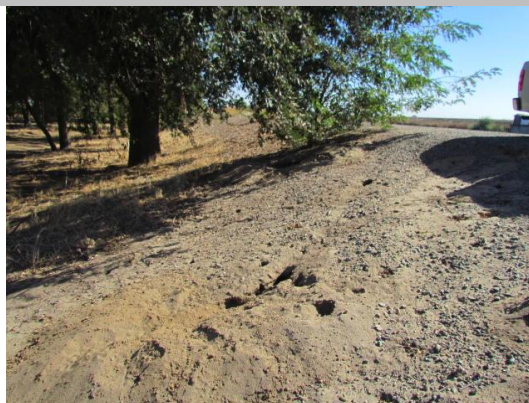
Photo 1 of 2 : SP\_2016\_RD0544\_109\_67\_20160404\_00054.jpg

LM Start	3.58	Rating **	U	Issue No.	67
LM End	3.58	Issue Type +	Ma	Location *	LS
Category	Earthen Levee			GPS Latitude/Longitude	
				Start	End
Item	Animal Control			37.819419 °	37.819419 °
				-121.365854 °	-121.365854 °
DWR ID	DWR_RD0544_02_f_2015_67				
Comment Code					
A1 : Exterminate rodents and backfill and compact or grout burrows.					
Inspector Comment					
Large rodent holes on landward slope.

Looking northeast at typical view of rodent holes on landward slope.

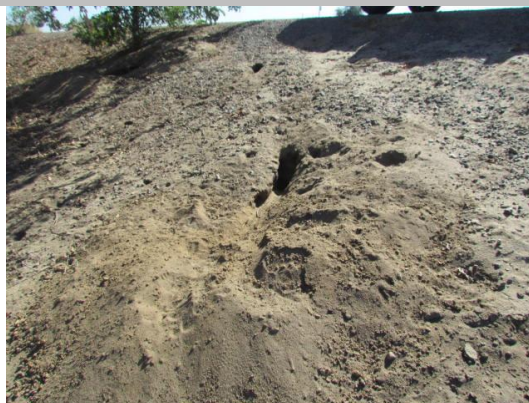
Photo 2 of 2 : SP\_2016\_RD0544\_109\_67\_20160404\_00055.jpg

Looking north at typical view of rodent holes on landward slope.

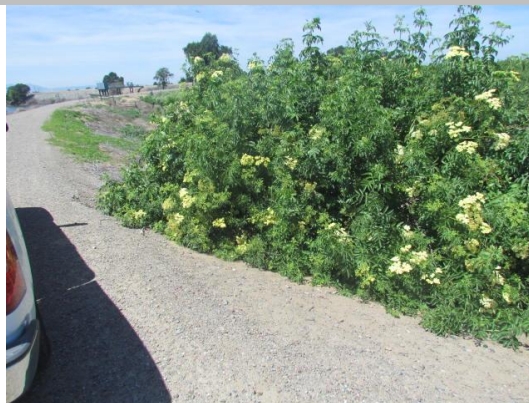
Photo 1 of 1 : SP\_2016\_RD0544\_109\_64\_20160404\_00052.jpg

LM Start	4.05	Rating **	U	Issue No.	64
LM End	4.05	Issue Type +	Ma	Location *	LS
Category	Earthen Levee			GPS Latitude/Longitude	
				Start	End
Item	Vegetation			37.821620 °	37.821620 °
				-121.373283 °	-121.373283 °
DWR ID	DWR_RD0544_02_s_2015_64				
Comment Code					
V4 : Elderberries are blocking visibility and flood fight capability.					
Inspector Comment

Looking southwest at dense elderberry bush on landward slope and toe.  
(Spring 2015)

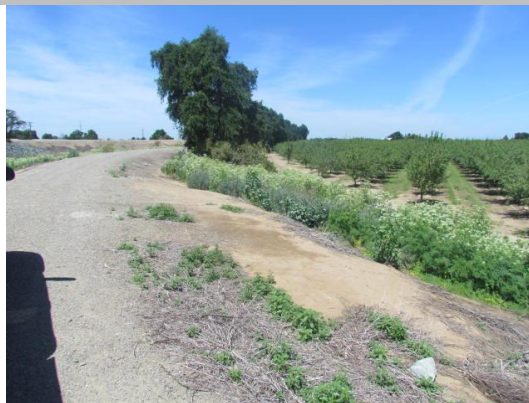
Photo 1 of 1 : SP\_2016\_RD0544\_109\_65\_20160404\_00053.jpg

LM Start	4.10	Rating **	U	Issue No.	65
LM End	4.16	Issue Type +	Ma	Location *	LS
Category	Earthen Levee			GPS Latitude/Longitude	
				Start	End
Item	Vegetation			37.821870 °	37.822623 °
				-121.374125 °	-121.374695 °
DWR ID	DWR_RD0544_02_s_2015_65				
Comment Code					
V2 : Remove the wild growth other than native grasses from the levee slopes.					
Inspector Comment

Looking southwest at dense vegetation on landward slope and toe.  
(Spring 2015)
